Aero Accessories, Inc. SERVICE BULLETIN

Spark Plug Information

Service Bulletin Number: SB-005

Subject: Cautions against excessive use of thread lubricant.

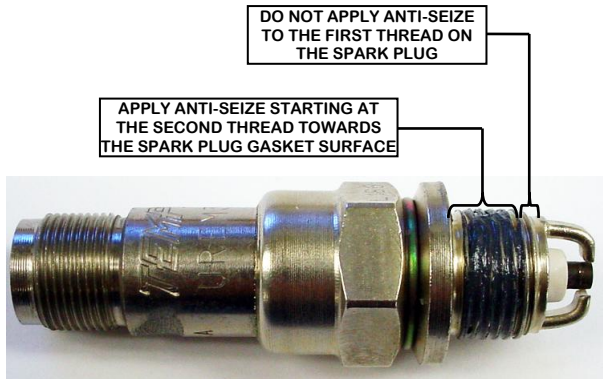
FIGURE 1
ANTI-SEIZE APPLICATION

Corrective Action: Graphite based thread lubricant/anti-seize is preferred. Regardless of what type anti-seize is used, Do Not apply it to the first thread on the spark plug. Apply the anti-seize sparingly, starting at the second thread and thence towards the spark plug gasket surface (see Figure 1). Make sure no anti-seize is on the firing end of the spark plug and that no anti-seize enters the cylinder. The photos (Figures 2 thru 4) attached show the residue from a copper containing anti-seize material. It contaminated the spark plugs and caused them to misfire. After cleaning, the plugs performed normally.

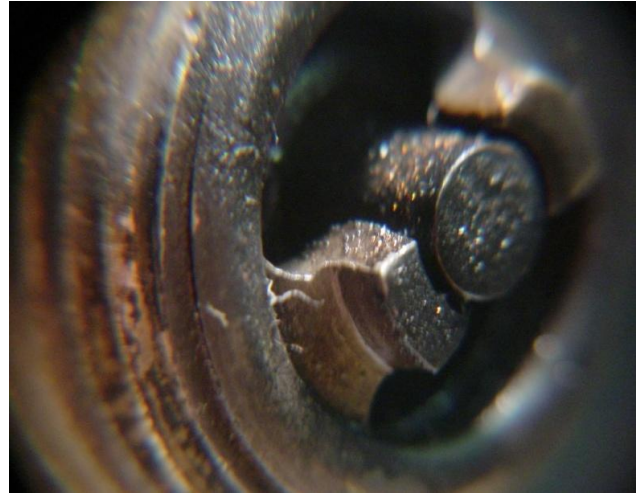
Background: If anti-seize material gets onto the electrodes of the spark plug it can cause misfiring. Some anti-seize compounds contain metals suspended in grease or oil. If introduced into the combustion chamber the carrier material burns away or, alternatively, is deposited on the firing end of the spark plug along with metallic particles. The metallic particles provide a path to ground for the spark. Metallic particles in the gap area effectively reduce the gap. Although the plug may fire, the spark may not be powerful enough to ignite the fuel.

FIGURE 2
COPPER DEPOSITS ON ELECTRODES

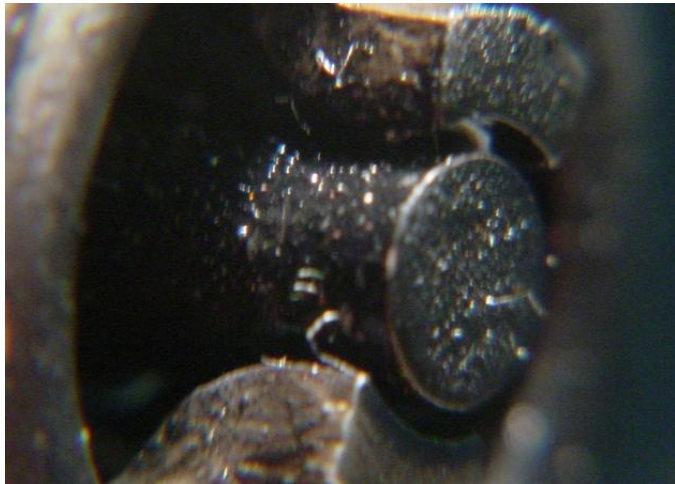
FIGURE 3
COPPER PARTICLES IN GAP

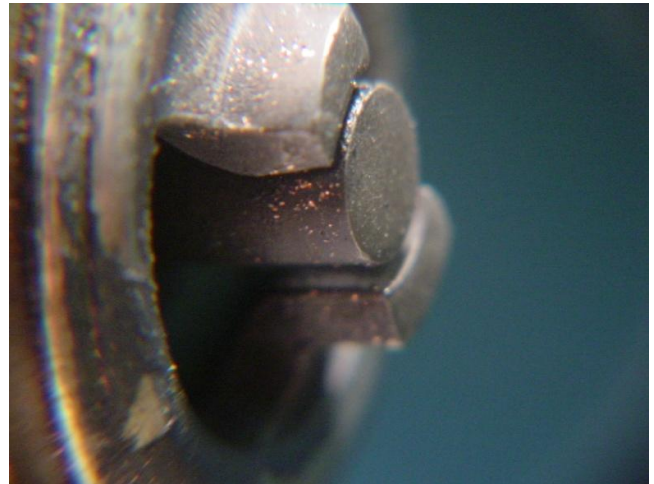
FIGURE 4
COPPER DEPOSITS ON ELECTRODES
