Remote Oil Filter

Service Bulletin Number: SB-006

Subject: Cautions regarding externally mounted oil filter installations. A number of reports over the past few years address remote oil filter adapter issues that led to ruptured or damaged filters. In each case, regardless of the oil filter's manufacturer, the filter was installed on a remote filter adapter or on an aftermarket oil filter adapter mounted on the engine.

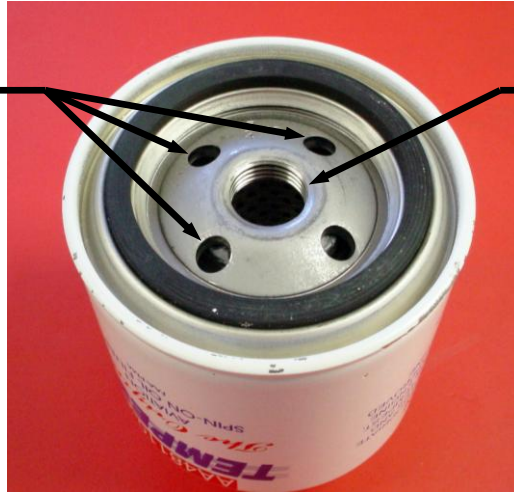
FIGURE 1
INLET AND OUTLET HOLES

Oil Enters Filter Through
The Ring of Small Holes
(FLOW FROM ENGINE)

Oil Exits Filter Through
The Center Hole
(FLOW TO ENGINE)

Oil is supposed to enter the filter through the ring of small holes that surround the central hole in the filter base and supposed to leave the filter (go to the engine) through the central hole, see Figure 1. If the hoses are crossed, the filter element may be displaced and block oil from leaving the filter. Pressure in the filter will rise until the case bursts.

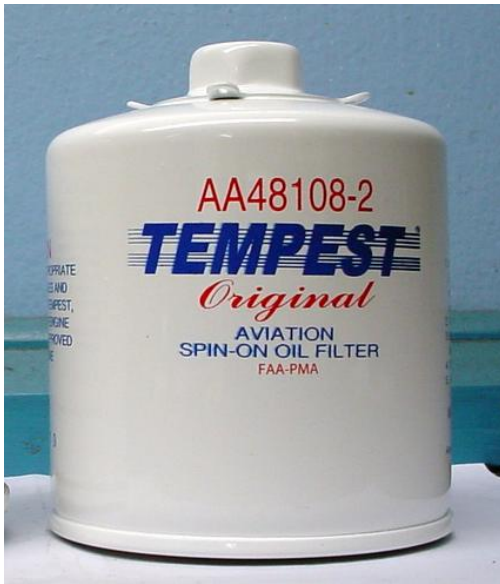
FIGURE 2
NORMAL FILTER CASE

Figure 2, shows a normal filter case. Compare the curvatures in the tops of the filters in figures 2 and 3, and the separation around the base where the rolled seam is separating.

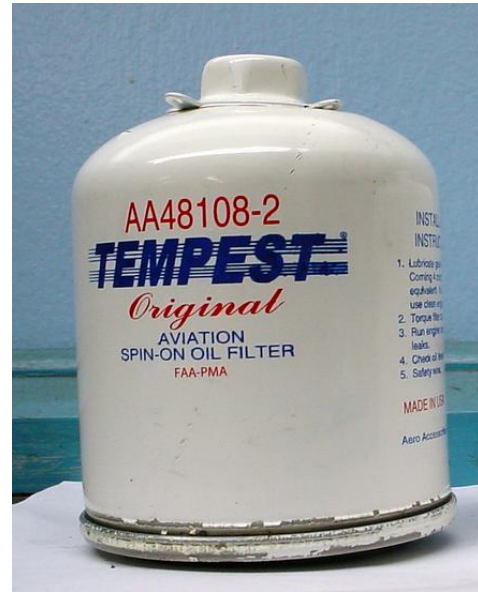
FIGURE 3
BURST FILTER CASE FROM
OVERPRESSURE

Some Lycoming spin on filter retrofits require an adapter plate and gaskets at the engine accessory case. If the plate or gaskets are installed incorrectly, the oil pressure in the filter will rise and the filter case may be ruptured, see Figure 2.

Figure 3, shows a burst filter case seam that resulted because a diverter plate and gaskets at the engine accessory case were incorrectly installed. To burst the seam typically requires over 600 psi pressure. When such pressures are reached the oil pump gears and drive assembly in the engine are put under extreme loads. It is possible that the oil pump gears and their drive system can be damaged by the high loads.

ALWAYS THOROUGHLY INVESTIGATE any burst filter case or seam and correct the problem(s) that caused it prior to further flight. The extremely high burst rating of aviation oil filters means that when a filter ruptures some malfunction/situation in the engine or oil system has caused the event.
